TITLE: Proceedings of the Antenna Applications Symposium Held in Urbana,
Illinois on 17-19 September 1986. Volume 1.

EHF/SHF SATCOM ANTENNA AND RADOME TEST RESULTS

Allen L. Johnson
Wayne O. Fischbach
Avionics Laboratory
Wright-Patterson AFB, Ohio 45433

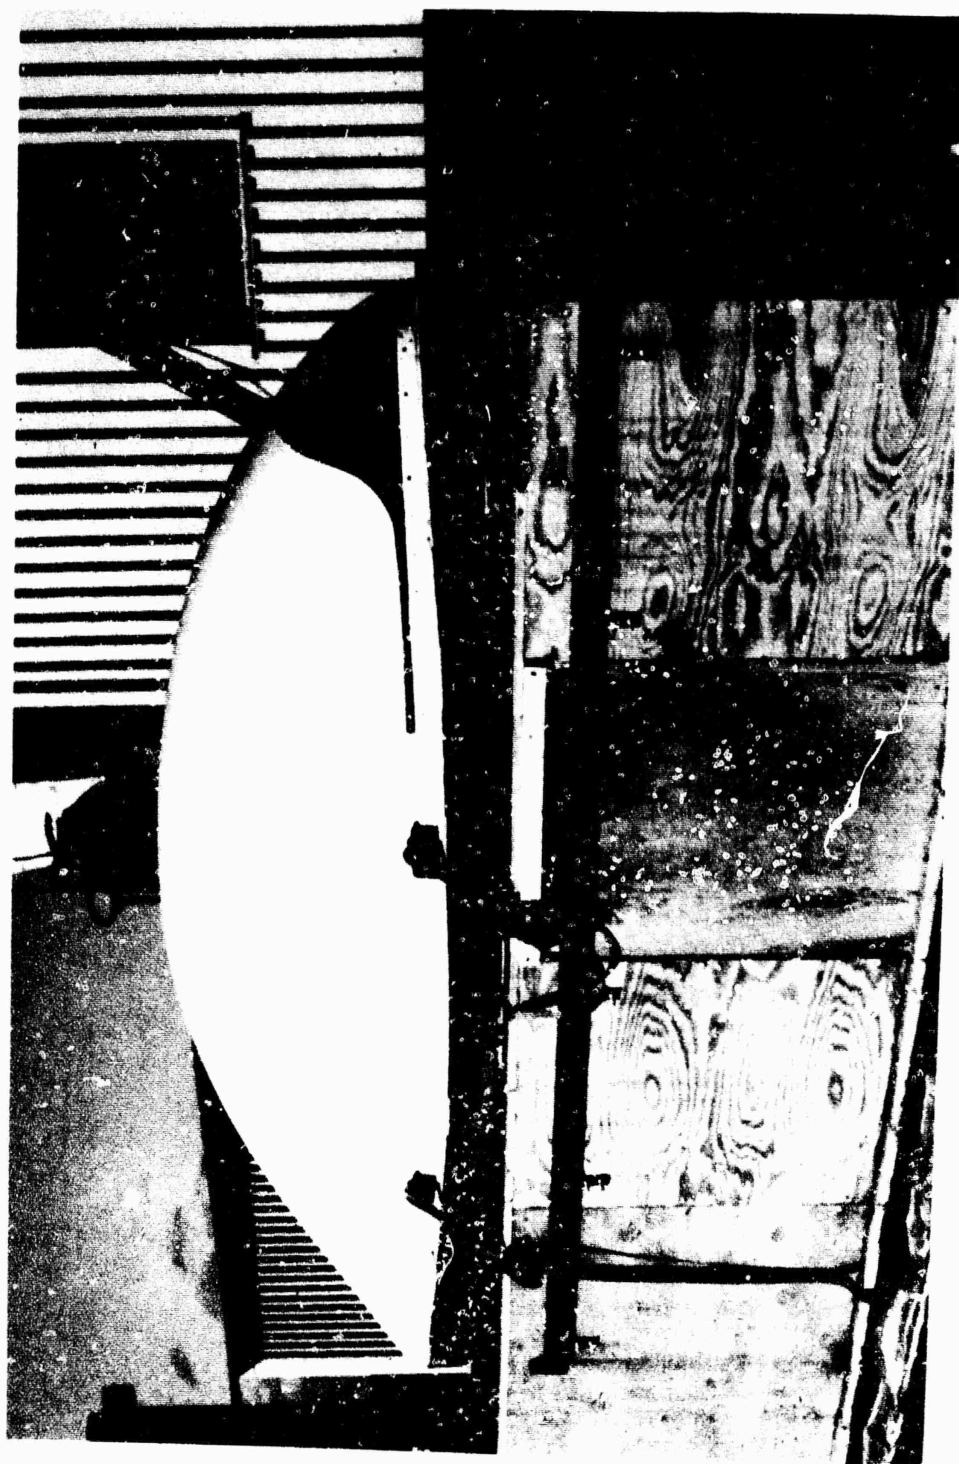
FIGURE 3 ANTENNA/RADOME TEST FIXTURE FOR TEMPERATURE & RFI TEST

When an SHF transmitted beam passes through the radome, local RF heating will occur. For the RF heating tests a special test fixture was constructed to simulate a section of the C-135 aircraft fuselage. The AN/ASC-18 airborne SATCOM antenna was mounted on the fixture and the tri-band radome installed over the antenna,

Figure 3. The AN/ASC-18 terminal, which was installed in the nearby Rooftop Facility, has a power output of 10 kW in the SHF band. To conduct the test, the SHF transmitter was turned on and operated until the radome's inside temperature stabilizes. The extent of the heating was measured by attaching a series of heat tabs (which blacken at a specific temperature) around a 15 inch diameter circle inside the radome in the area where the antenna beam intercepted the radome. The test procedures require the SHF transmit power to be raised from a 2 kW level to a maximum of 10 kW in four steps. At a 10 kW transmit power level, the uniform energy density from the antenna would be $12.4 \text{ watts/inch}^2$. In the near field, the energy distribution is not uniform and it was anticipated that "hot spots" could occur with energy densities of 20 watts/inch^2 . Tests with flat panels of the radome material indicated that at 8 GHz the loss in the radome is approximately 2dB (60% transmission). In a hot spot it was expected that 8 watts/inch^2 could be dissipated in the radome skin. The maximum temperature was determined for each power level by reading the highest temperature heat tab which had fired (blackened).

couples into the 20 GHz antenna/receiver and the 7 GHz noise from the 44 GHz transmitter that couples into the 7 GHz antenna/receiver were measured. Both antennas were mounted on the test fixture, under the tri-band radome. Receiver measurements were made as each transmitter was turned on. The antennas were positioned at various geometrics; both pointed toward the same equal-angle reflection point, both antennas normal to the radome wall, and the antennas pointed almost directly toward each other.

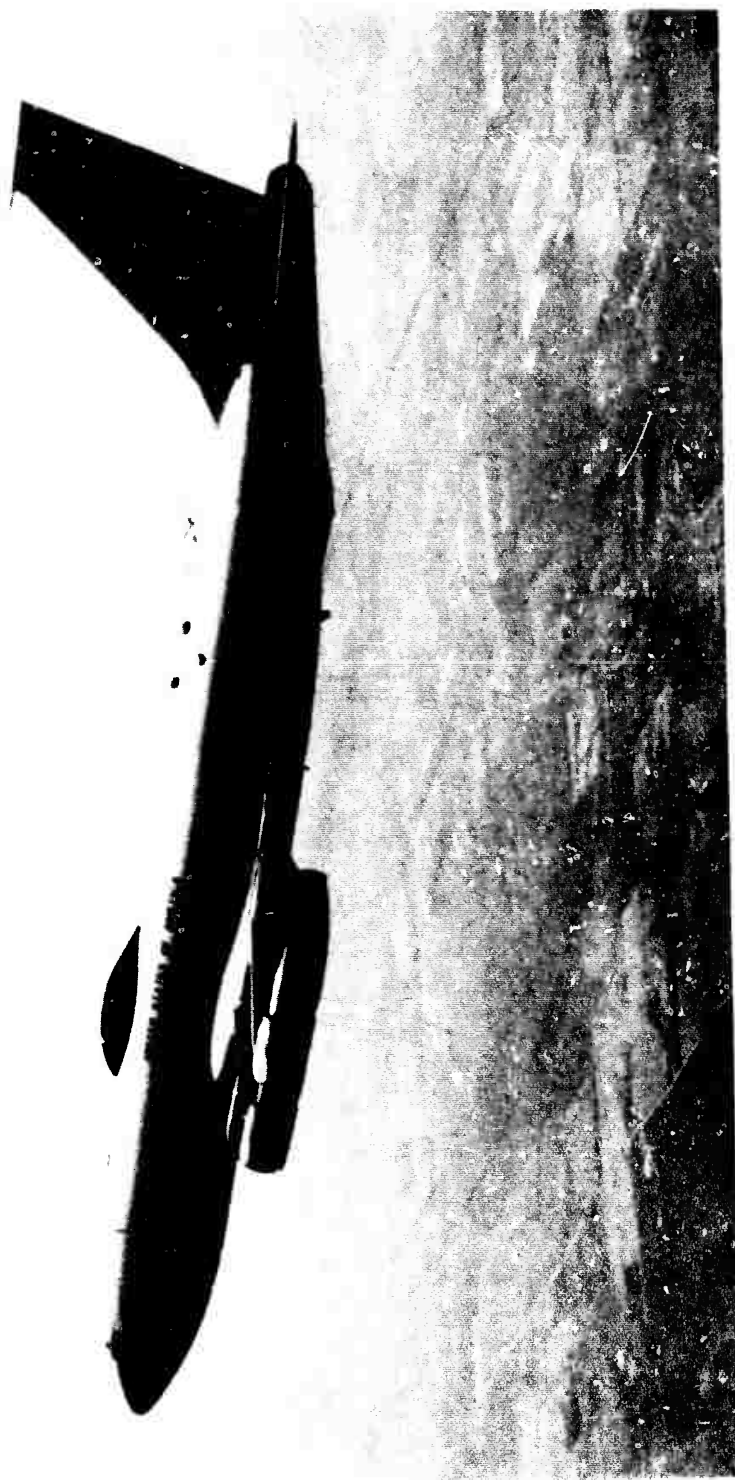
FIGURE 4 AN/ASC-30 RADOME ON C-135 AIRCRAFT

The AN/ASC-30 system employs a 26" parabolic antenna that is mounted on top of a C-135 test aircraft. An aerodynamic radome covers the antenna to reduce the drag, Figure 4. Since the radome has to pass three frequency bands (7-8 GHz, 20-21 GHz, and 43-45 GHz), a special wall thickness design was required. The resulting thin-wall radome design did not have sufficient stiffness to meet deflection limits during maximum aerodynamic loading. To improve the stiffness, three ribs were added to the radome, Figure 5. The final design was run on a NASTRAN computer model (WANG, 1984) to calculate the radome wall deflection during an 8° aircraft sideslip, the maneuver specified as providing the maximum dynamic loading to the sides of the radome.
